**MERIT Hg System Decommissioning at CERN  
Van Graves, Oak Ridge National Laboratory  
February 12, 2008**

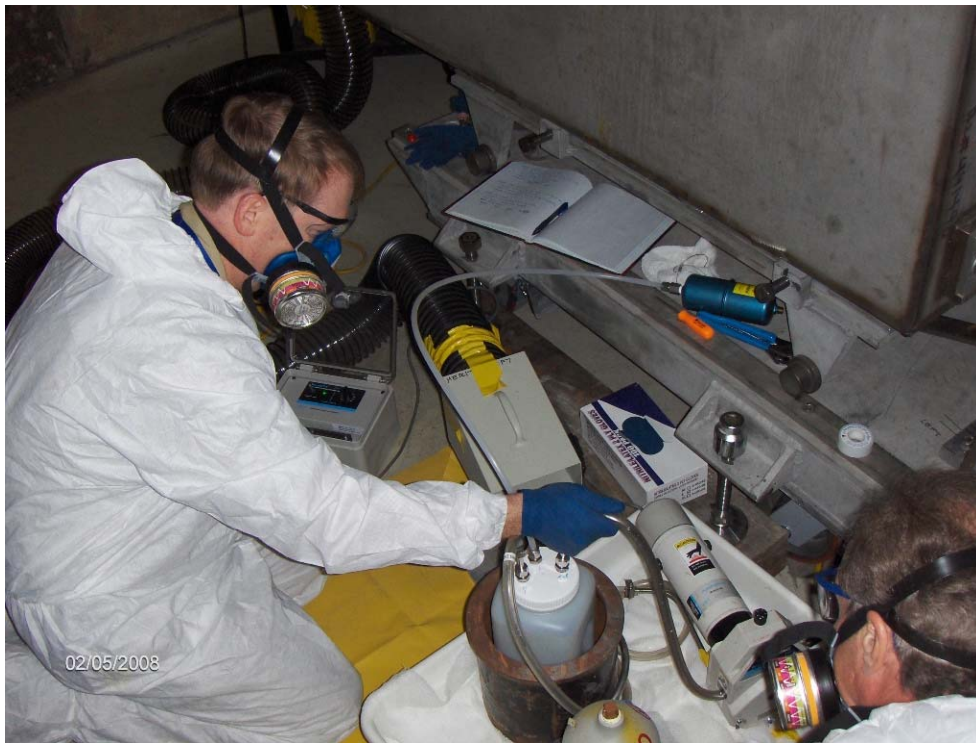
**Figure 1. Mercury draining operations**

transfer into the shipping flask. During the first flask transfer, this valve was inadvertently left open, which allowed the Hg experimental equipment to gravity-feed into the intermediate container, resulting in a small overflow. This overflow allowed mercury spillage into the surrounding retention containers and partly on the concrete tunnel floor. Total overflow volume was approximately 200 ml, of which approximately 50 ml left secondary containment and made it to the floor.

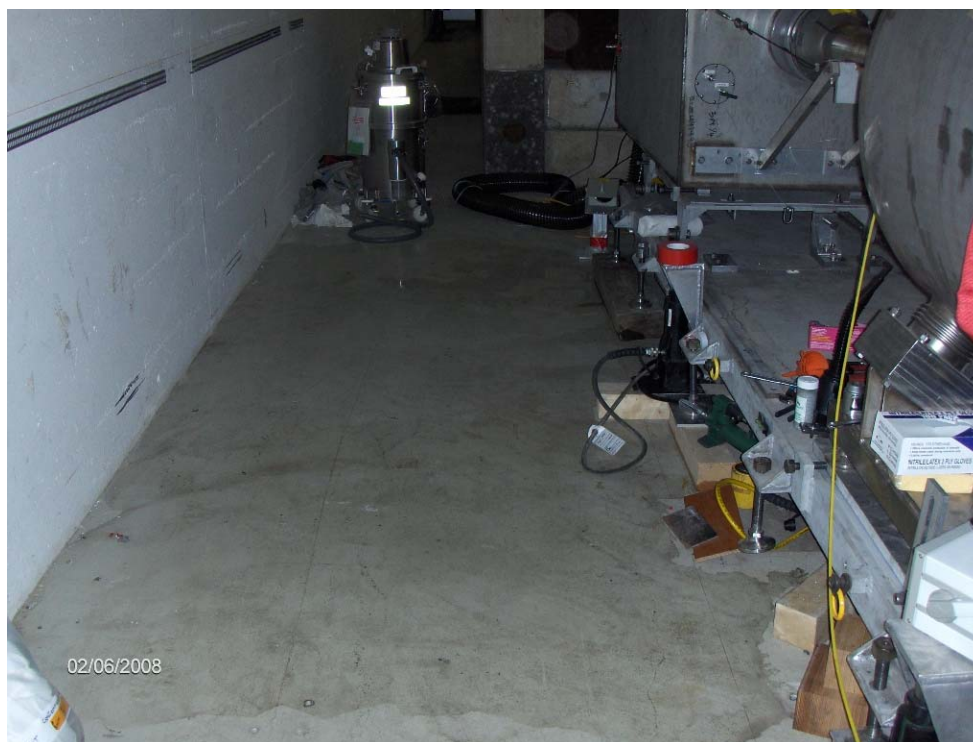
**Figure 2. Area of cleanup efforts**

After the draining operations were concluded, follow-on cleanup of the spill area was performed over the next few days. Hand wiping of the floor and equipment was performed multiple times using first a sulfur-impregnated water solution, and then a Hg-absorbent powder. By the end of the week, vapor levels at the floor had been reduced to approximately 20  $\mu\text{g}/\text{m}^3$ , which is below the recommended maximum vapor exposure levels for workers during an 8-hr day. Figure 2 shows the area after the cleanup efforts were concluded.
